Troubleshooting Gel Electrophoresis on the ABI 373 and ABI PRISM 377

Overview This section shows examples of common problems that can occur with gel electrophoresis. Refer to the table on [page 7-53](#) for a more complete guide to troubleshooting gel electrophoresis.

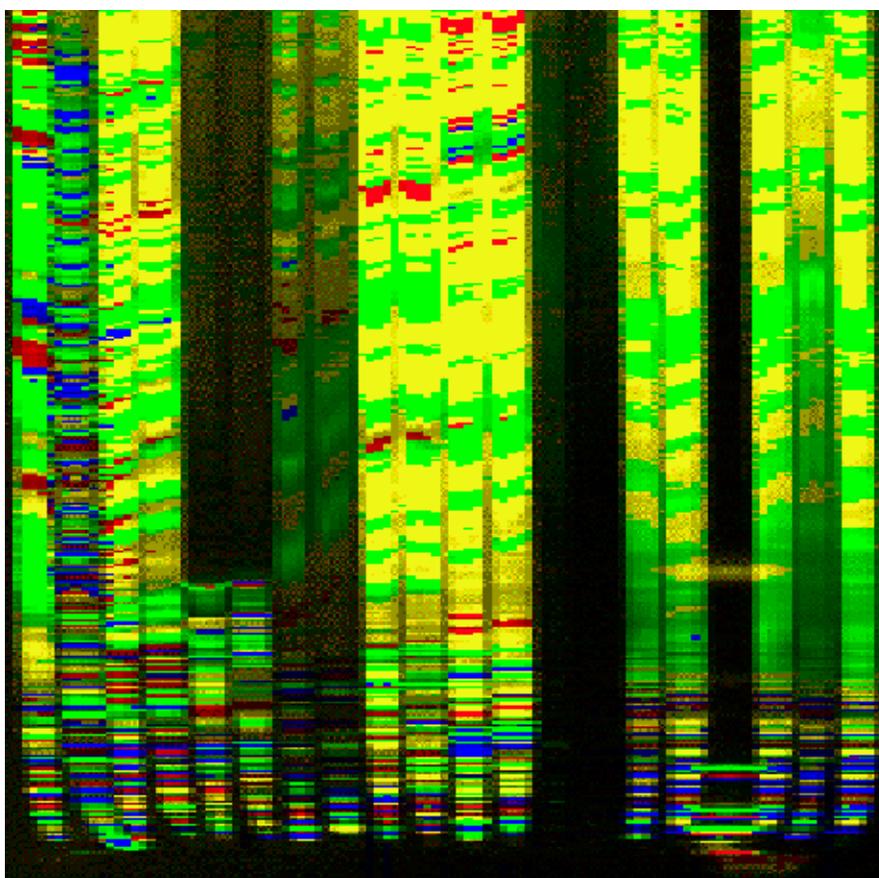
Poor-Quality Acrylamide Use fresh, high-quality acrylamide. Poor quality acrylamide contains acrylic acid (a deamidation product) and linear polyacrylamide, which will copolymerize and cause local pH changes in the gel. This causes streaking and smearing of bands ([Figure 7-50](#)).

Figure 7-50 Effect of poor quality acrylamide on sequencing data

During storage at room temperature, especially in water, acrylamide breaks down into acrylic acid. Prepare only as much acrylamide-bisacrylamide solution as you will need in a month.

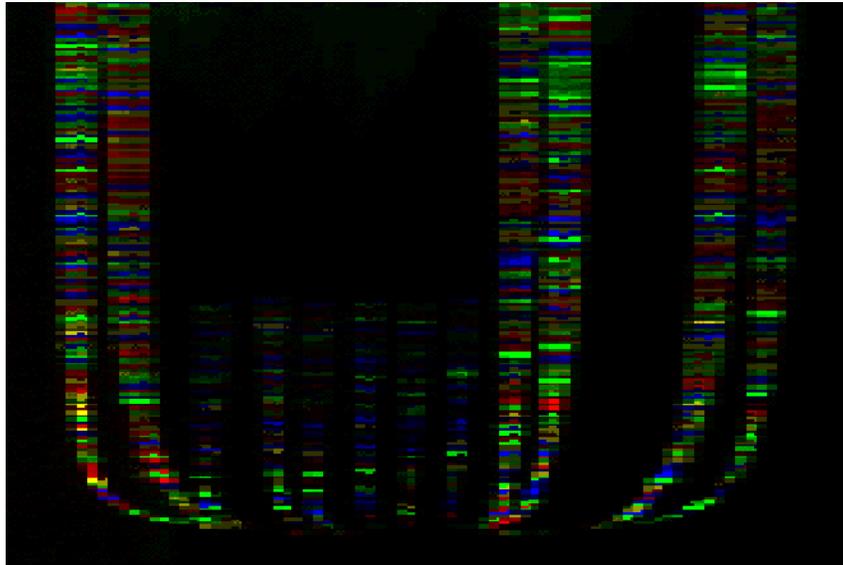
Salt Excess salt in the wells can cause pinching of lanes toward the center of the gel (Figure 7-51).

Note Lanes 3–8 are short PCR products. Lane 11 was not loaded.

Figure 7-51 Effect of excess salt on an ABI PRISM 377 gel. The overall signal strength is also lowered.

When performing ethanol precipitation, remove all of the ethanol by aspiration after the first spin. If residual ethanol is dried down with the sample, the pinching and bending of lanes is worsened. Performing a 70% ethanol wash after ethanol precipitation of dye terminator reactions also helps to alleviate this problem.

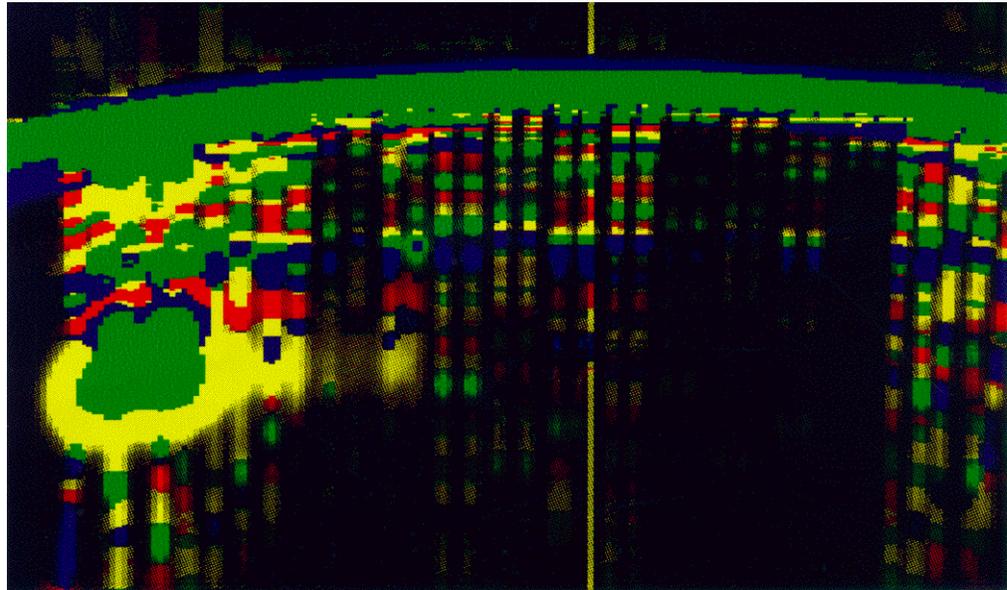
Contaminating fluorescent species can obscure sequencing data completely. A common cause of fluorescent contamination is ink from marker pens. Do not write on the gel plates, spacers, combs, or buffer chambers.

In [Figure 7-52](#), a large green band is seen shortly after the first fragments are detected. The band is from a marking pen that was used to label a spacer. Even though the spacer was cleaned before use, enough ink remained to ruin the sequencing data.

Figure 7-52 Fluorescent contamination from a marking pen

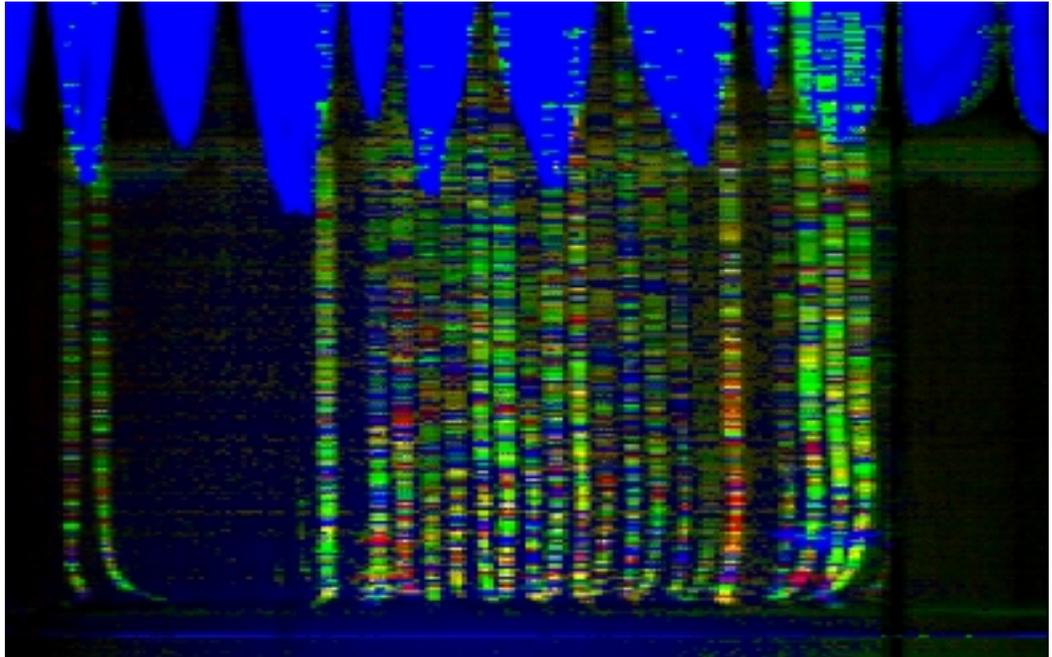
Buffer Leaks If buffer spills or leaks onto the read region of the gel plates, it can cause blue or green artifacts on the gel image ([Figure 7-53](#)).

Figure 7-53 Buffer leak in the read region of the plates

To avoid buffer leaks, make sure that the plates are clamped correctly and that the upper buffer chamber gasket makes a proper seal. Do not spill buffer behind the upper buffer chamber, as wicking can occur.

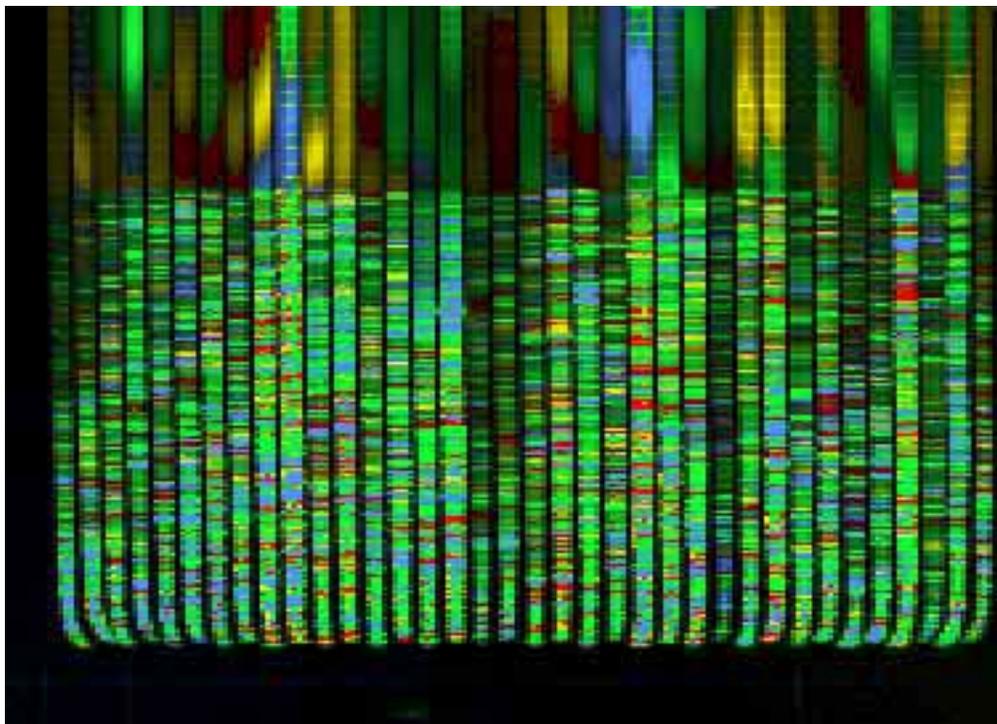
Buffer leaks or evaporation also can cause electrophoresis failure if there is not enough buffer for electrophoresis. Note that electrophoresis fails at the same point in each sample ([Figure 7-54 on page 7-48](#)), causing diffuse bands to appear throughout the rest of the run.

Figure 7-54 Electrophoresis failure caused by a buffer leak

To prevent this from happening:

- ◆ Clean the front plate well, so the gasket will make a good seal.
 - ◆ Use the lid on the upper buffer chamber.
 - ◆ Take care when filling the upper buffer chamber not to spill buffer behind it.
 - ◆ Do not fill the upper buffer chamber to the top because buffer will wick over the ears of the notched plate and run down the sides or back of the gel plates.
 - ◆ Check gasket for leaks before starting the run.
-

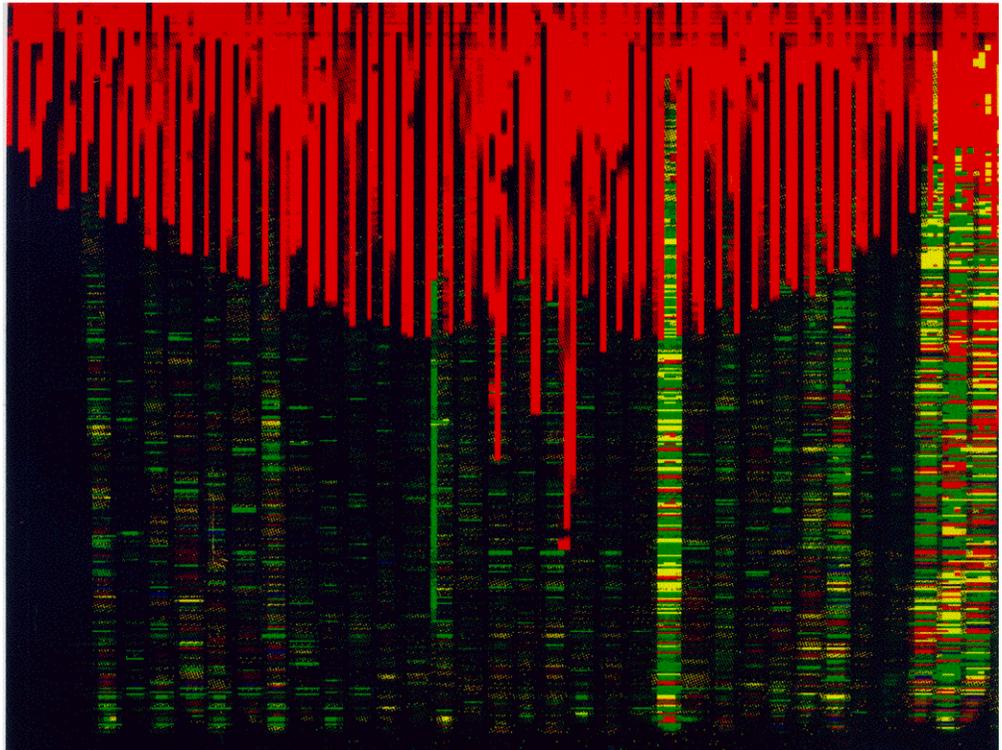
Red Rain Gel destruction in the read region of the gel can cause red streaks in the data, often near the end of the run (and therefore near the top of the gel image). This effect, shown in [Figure 7-55](#), is known as “red rain.”

Gel destruction often results from drying out of the gel, and is exacerbated by extreme run conditions, *e.g.*, high voltage, high power, high temperature, and long run times.

Figure 7-55 “Red rain” on a 48-cm, 36-lane ABI PRISM 377 gel

The following can be used to help prevent red rain:

- ◆ Wrap the gel plates to prevent the gel from drying out.
- ◆ Lower the run temperature from 51 °C to 48 °C.
 - A lower temperature results in a slower run speed. Less data is collected in the same run time.
 - A lower temperature also means less denaturing power in the gel, which can lead to more extension product secondary structure in the gel. This can result in more compressions, particularly with dye primer chemistries (see [page 7-31](#)).

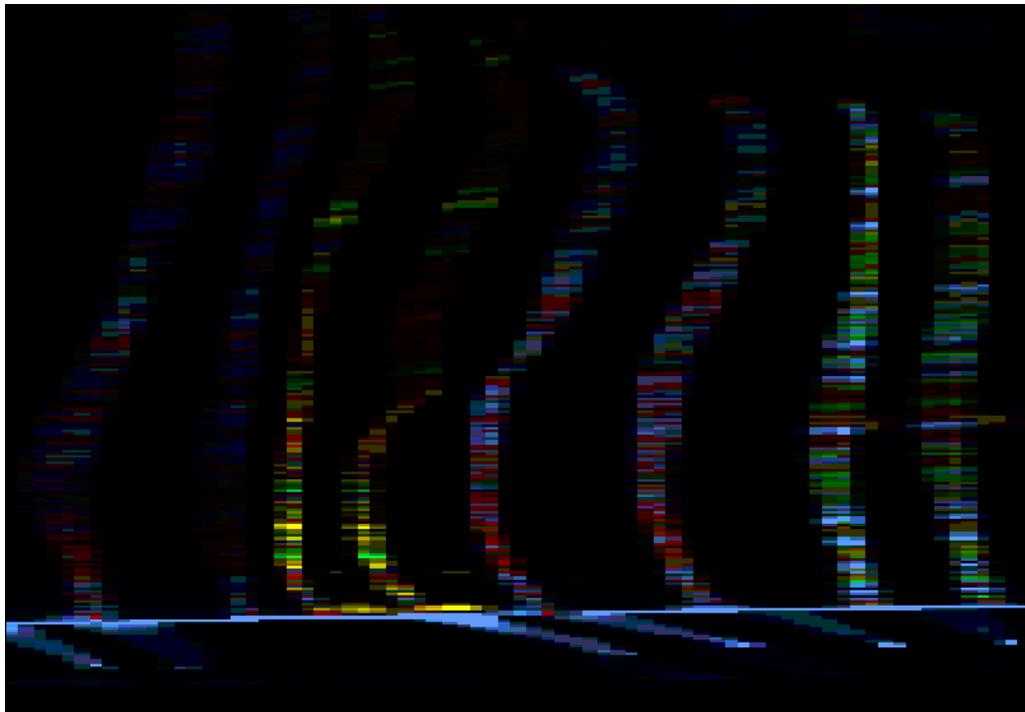
Gel Extrusion When voltage is applied on the ABI PRISM 377 DNA Sequencer, the polyacrylamide gel sometimes moves from between the glass gel plates toward the cathode (upper electrode) and into the upper buffer chamber. In extreme cases, up to about five centimeters of gel in a folded sheet can be deposited in the chamber.

This “gel extrusion” usually begins at the start of a run or even during the prerun. It is believed to be caused by a buildup of charge on the surface of the glass plate such that the gel is not bound to the plate after pouring. As the voltage is applied, the gel migrates toward the upper electrode.

The gel image can show a variety of anomalous effects, including catastrophic loss of resolution, lane splitting, extreme band tilt, and band distortion ([Figure 7-56](#)).

Figure 7-56 Effect of gel extrusion on sample migration

Almost all known cases of gel extrusion have been resolved by either acid washing or alcoholic KOH washing. Refer to the cleaning procedures on [page 4-9](#).

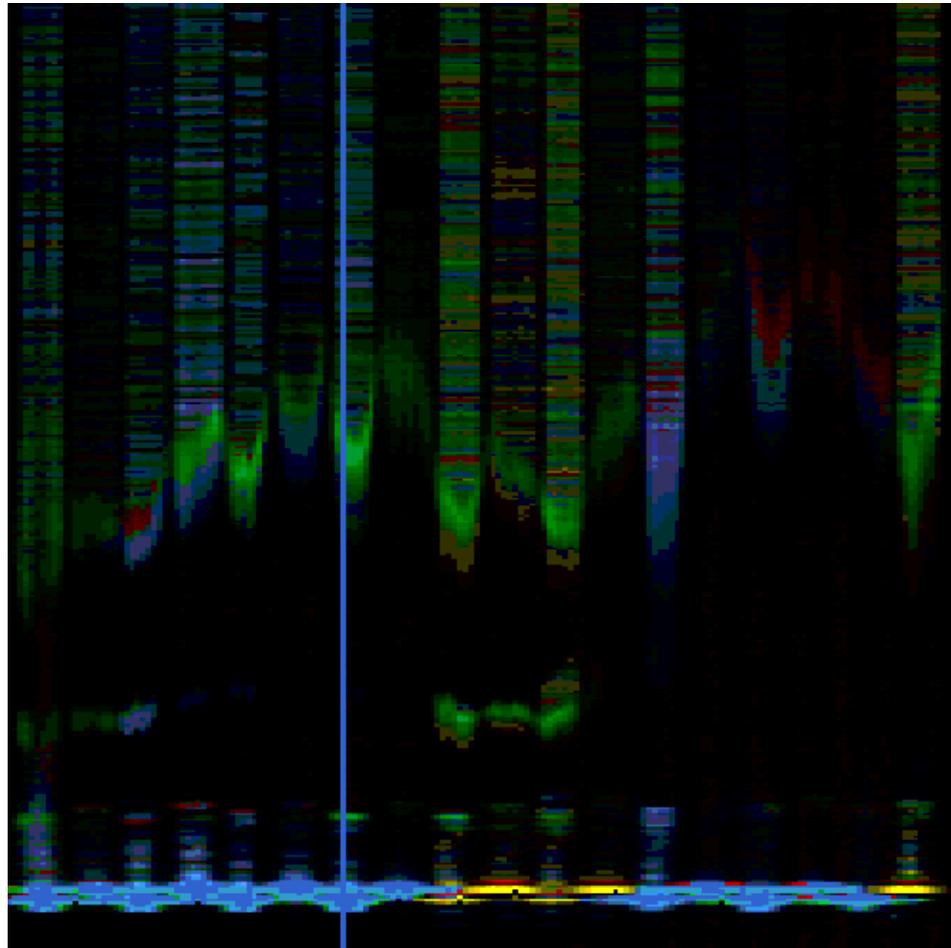
This problem usually occurs at the beginning of the gel (between 150 and 250 base pairs in the analyzed data). It manifests itself as a band of little or no signal across the entire width of the gel image (Figure 7-57). Temporary loss of signal has been traced to contaminants on the gel plates. These contaminants include surfactants, fatty acids, and long chain polymers that are not removed when the plates are washed.

Figure 7-57 Portion of an ABI PRISM 377 gel image showing temporary loss of signal. The vertical blue line is from dust in the read region of the gel.

Rinsing glass plates with hot deionized water (90 °C) has been found to remove the contaminants that cause temporary loss of signal. Refer to page 4-9 for more information.

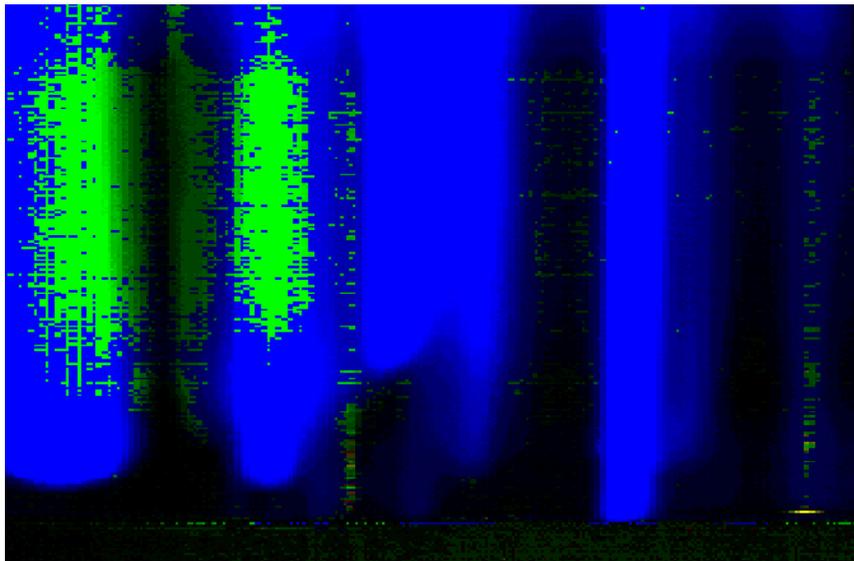
Plates from vendors other than PE Applied Biosystems may not have adequate quality control for use on our instruments. Several problems result from poor quality plates, including warping. [Figure 7-58](#) shows data from plates that warped after 6 months of use.

When plates become warped, the laser is no longer focused correctly on the gel. When this occurs on the ABI 373 DNA Sequencer, laser light is scattered back to the detector, causing the gel image to appear blue and green and obscuring data. On the ABI PRISM 377 DNA Sequencer, there is a filter to keep out most of the scattered laser light. Data quality still suffers because the scattering results in less excitation of the dyes by the laser.

Figure 7-58 Effect of warped gel plates on ABI 373 sequencing data

Always use high-quality gel plates.
